# The Impact of Polluting Sources on the Physical-Chemical Properties of Water in the Curved River in Kosovo

**Keywords:** Curved River, Pollution, Physical-chemical parameters, Ecological status, Mining

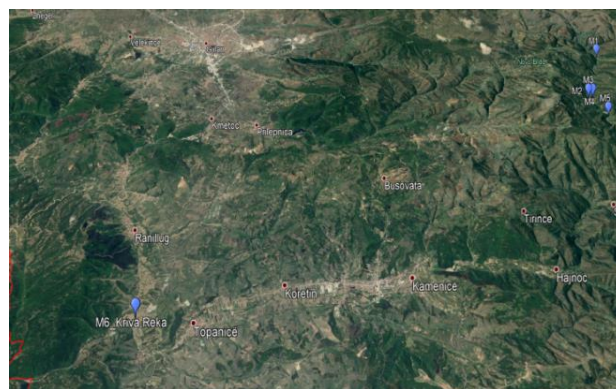
Figure 1: Complete monitoring network

Figure 1 reflects the entire monitoring network, four sampling sites located within the industrial area of the Artana mine (M<sub>2</sub>, M<sub>3</sub>, M<sub>4</sub> and M<sub>5</sub>) and two sampling sites outside the industrial area (M<sub>1</sub> and M<sub>6</sub>). Figure 2 shows the monitoring network within the industrial area, so sampling sites: M<sub>2</sub>, M<sub>3</sub>, M<sub>4</sub> and M<sub>5</sub>. Sampling site M<sub>1</sub> - represents the Curved River (Kriva Reka) before the discharge of mine waters. In this sampling site we have detected the waters of the Curved River in front of the industrial area of the Artana mine (fig.3), where the water, apart from urban pollution, should have no other pollution.

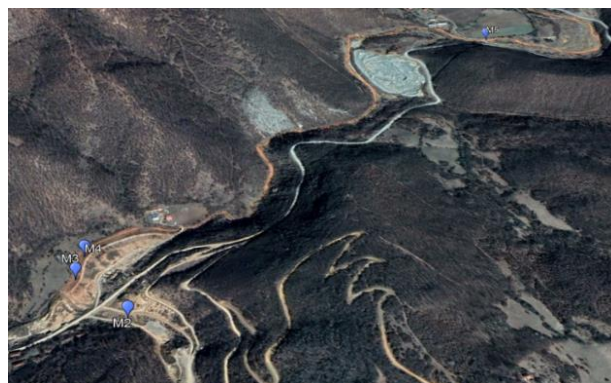
Figure 2: Monitoring network in the Artana area

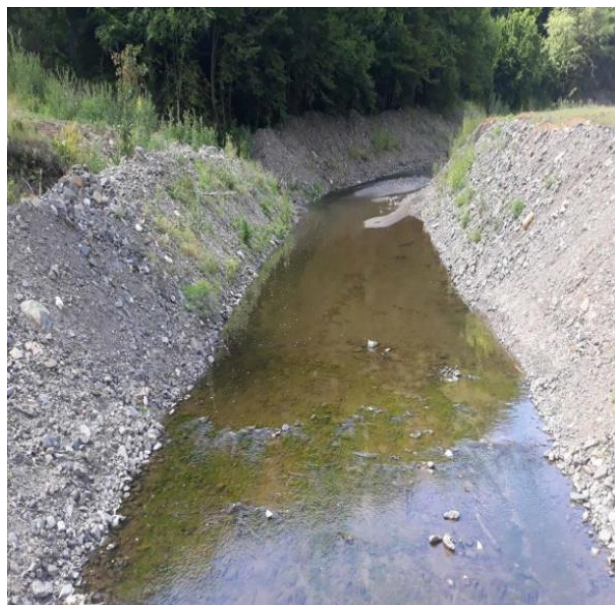
Figure 3: Sampling site M<sub>1</sub>

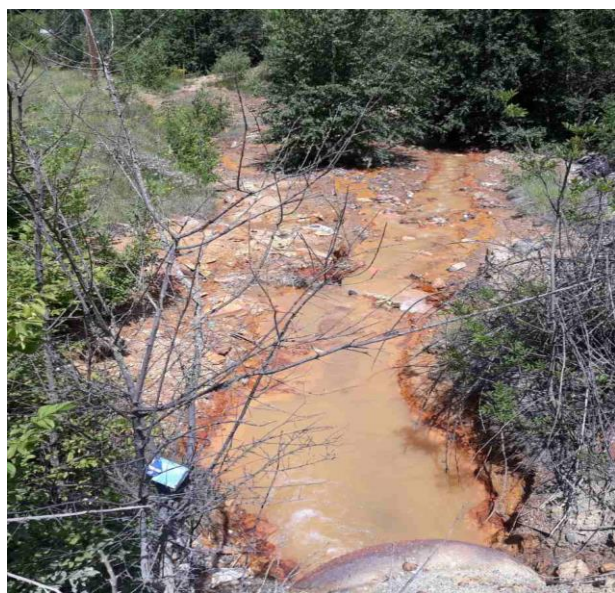
Figure 4: Sampling site M<sub>2</sub>

M<sub>2</sub> - Pollution from mine discharges: This sampling site reflects the critical place where the enormous and indiscriminate discharge of mine and flotation waters takes place (fig.4), which through a stream was thrown into the waters of the Curved River.

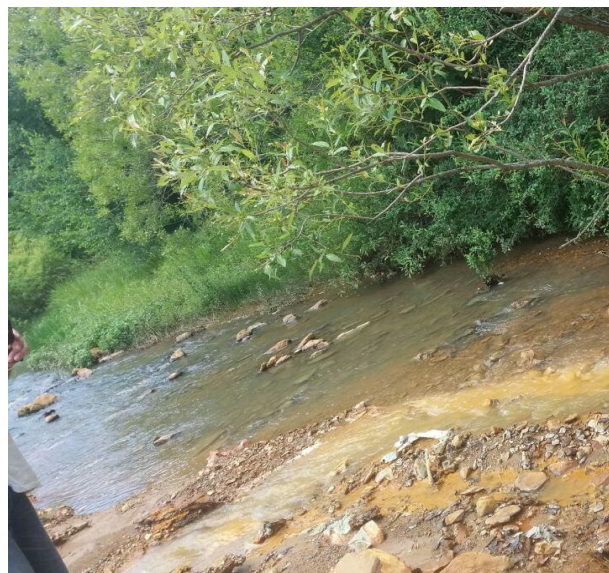
Figure 5: Sampling site M<sub>3</sub>

M<sub>3</sub> - Curved River after mine discharges: The waters of this sampling site represent the sample taken after discharges from the mine and flotation (fig. 5).

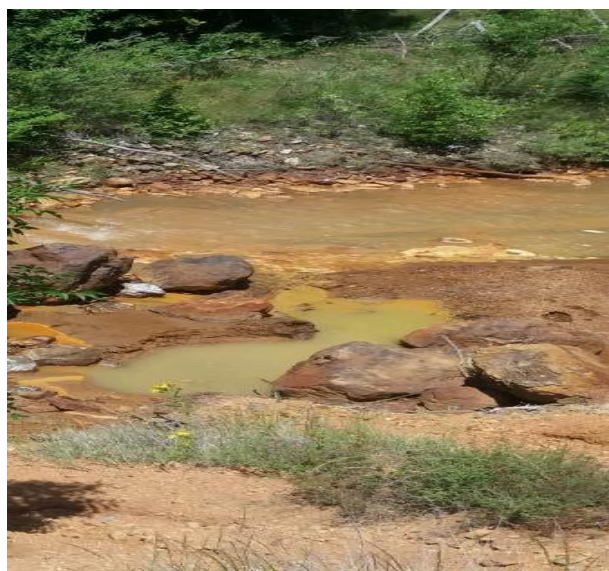
Figure 6: Sampling site M<sub>4</sub>

M<sub>4</sub> - Waters after the first landfill: We have targeted this sampling site to assess the pollution caused by the landfill drainage water (fig. 6).

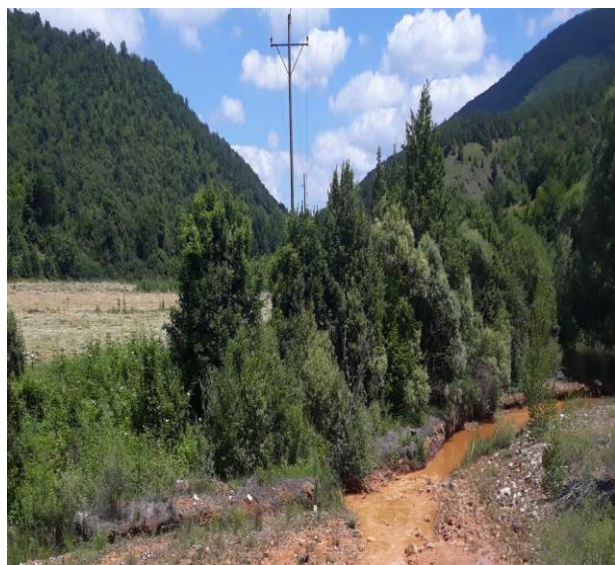
Figure 7: Sampling site M<sub>5</sub>

M<sub>5</sub> - Curved River after the second landfill: Sampling site M<sub>5</sub> presents the state of water quality of the Curved River, after the drainage of the second landfill (fig.7). This landfill is located at a distance of 1.7 k m from the first landfill. Like the first landfill, the draining waters of this landfill only increase the degree of concentration of pollutants in the waters of this river. As a result of atmospheric processes such as precipitation, sunning and

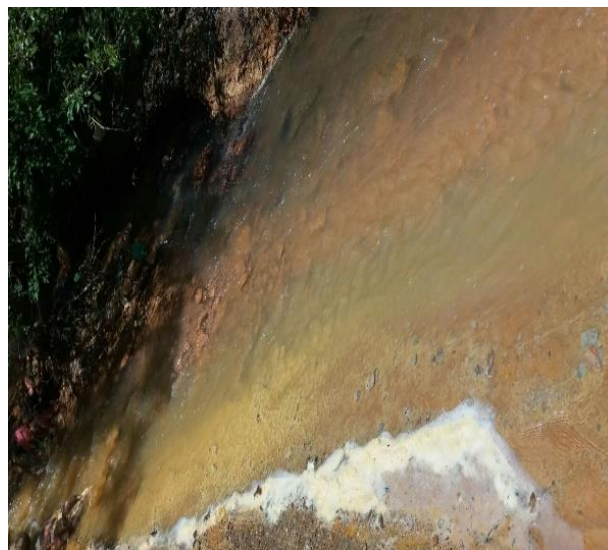
Figure 8: Sampling site M<sub>6</sub>

M<sub>6</sub> - Curved river before joining the Morava e Binçes river: This sampling site represents the last monitoring point of the Curved River waters (fig.8). For the sake of a more realistic assessment, we took the sample 800m before joining the Morava se Binçe River, which after joining the Waters River flows into the territory of Serbia. Therefore, this monitoring point gives us to understand that all waters belonging to this sub-basin are polluted by industrial, agricultural and urban sources.

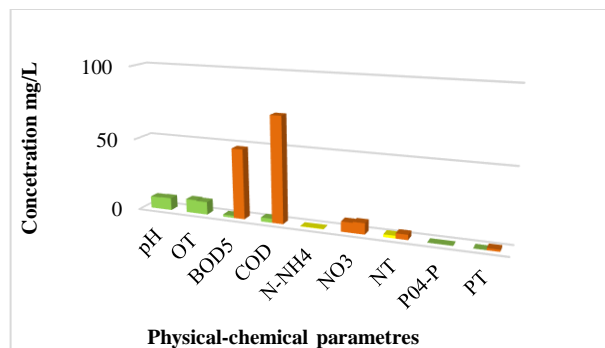
Figure 9: Concentration of physical-chemical parameters in sampling site M<sub>1</sub> (January and July, 2020)

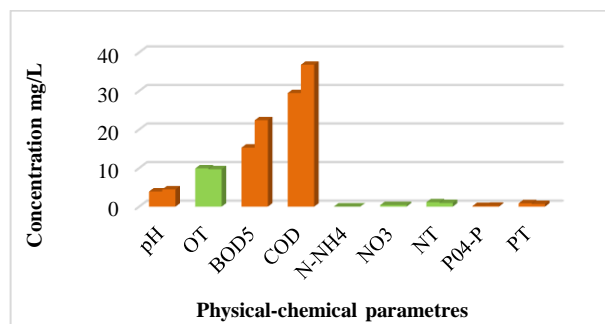
Figure 10: Concentration of physical-chemical parameters in sampling site M<sub>2</sub> (January and July, 2020)

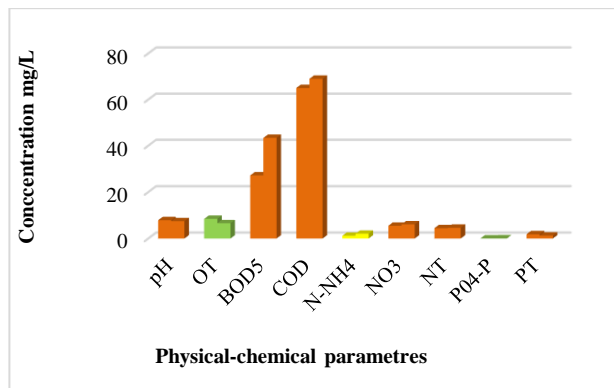
Figure 11: Concentration of physical-chemical parameters in sampling site M<sub>3</sub> (January and July, 2020)

Sampling site M<sub>3</sub>, except NH<sub>4</sub>-N, OT and PO<sub>4</sub>-P which present good and moderate status, other indicators reflect the poor ecological status of these waters (figure 11). M<sub>4</sub> represents the sampling site, where in addition to NH<sub>4</sub>-N, with good status, other indicators, for both months (figure 12), reflect poor status for water quality.

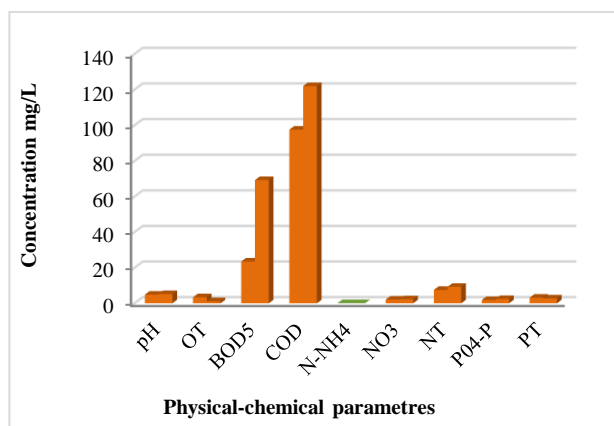
Figure 12: Concentration of physical-chemical parameters in sampling site M<sub>4</sub> (January and July, 2020)

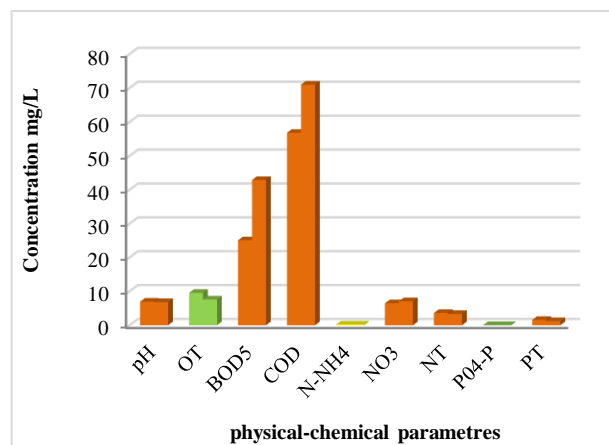
Figure 13: Concentration of physical-chemical parameters in sampling site M<sub>5</sub> (January and July, 2020)

In the M<sub>5</sub> remote sampling with good quality status, NH<sub>4</sub>-N was found, moderate OT and PO<sub>4</sub>-P, while other indicators for these waters, result in poor quality. The analyzes of the values obtained and reflected in tabular way (tables 4 and 5), prove that in all sampling sites, we have encountered poor (P) ecological status of the waters of this river. Sampling site M<sub>6</sub>, for two months, presents good condition for pH and PO<sub>4</sub>-P, moderate with OT, while other indicators (figure 14), result in poor ecological status of the water quality of the Curved River.

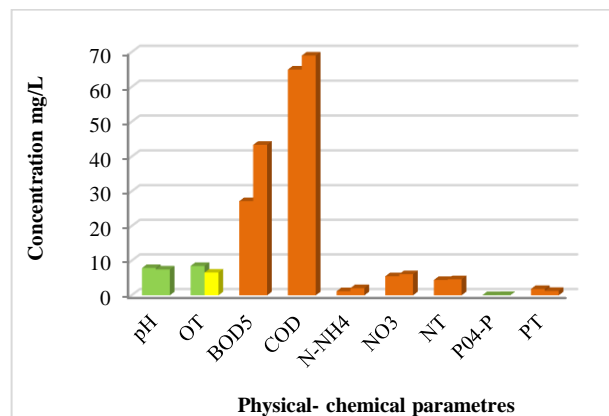
Figure 14: Concentration of physical-chemical parameters in sampling site M<sub>6</sub> (January and July, 2020)
