## Taming the Monster - Attabad Landslide Dam

Fiaz Hussain Shah, Arshad Ali\*, Muhammad Naseem Baig

National University of Sciences and Technology, Islamabad, Pakistan

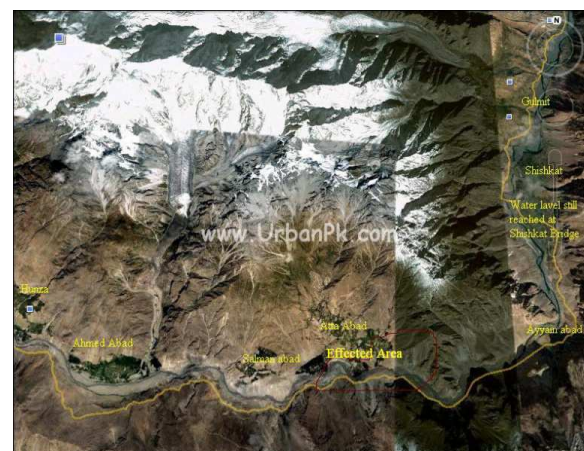
Figure 2: Land slide, lake and area around

In 1858, a landslide had erupted at Salmanabad, 3 kilometers downstream of present site (Figure 2). The Salmanabad landslide had also moved in forward, upstream and downward directions. In the process, it had deposited the thick layer of river gravel overlaying silty-clayey bed. Settlement of Attabad and Surat Villages was developed on this floor [7]. Tectonically the area lies in between Main Karakoram Thrust (MKT) and Main Mantle Thrust (MMT) zones and keeps experiencing shocks due to plate's movement [8]. As a result of Astore Earthquake 2002 [9] (6.3 on Richter scale) and Kashmir Earthquake 2005 (7.6 on Richter scale), this area of Gilgit-Baltistan had received intense tremors which had resulted into fractures and fissures [10].

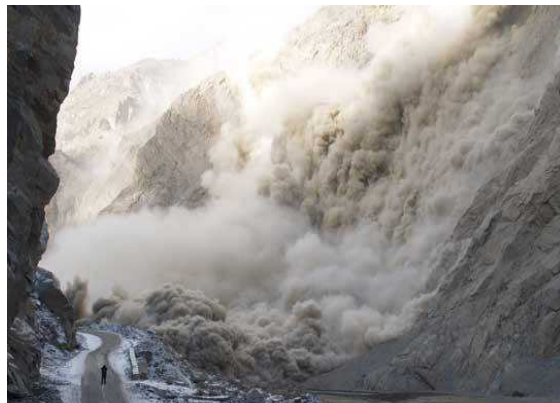
Figure 3: Dust rising at time of the slide

Landslide comprised all possible grain sizes from clay to silt, sand, gravel, cobbles and large boulders. One of the most prominent peculiarities of Attabad landslide was the presence of dark, black colored clay in substantial quantity which indicated the presence of high organic contents. The highly plastic clay of grey-blackish color had complicated the dynamics of landslide whereby maneuverability and work by the plant and equipment had become difficult. Another striking feature of the landslide was grayish dust indicating the dried nature of the slip mass. The dust took many days to settle finally accumulating a thick layer of about half a meter over the slip mass deposit creating unfavorable working conditions by humans and machines (Figure 3).

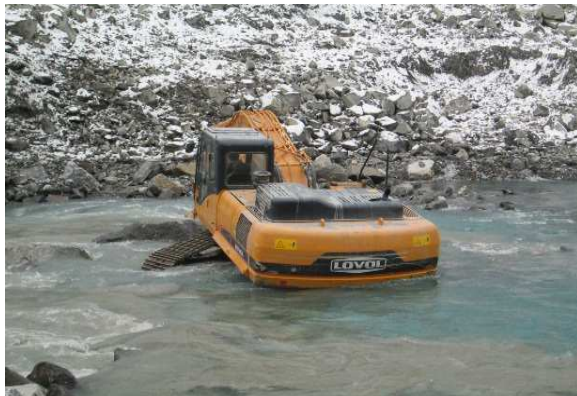
Figure 5: Perils of deepening the spillway

of landslide dam and ever expanding lake. Under extreme low temperature and in-conductive soil conditions, FWO mobilized one company of its Road Maintenance Battalion fully equipped with blasting specialists and experienced operators to cut a spillway in the slip mass and established a camp on the site. Although the working environment was too challenging, risky, demanding and fatiguing yet valorous and committed soldiers of Pakistan Army commenced the spill way cutting operation on 24/7 basis (Figure 5).
